U.S. DEPARTMENT OF LABOR MINE SAFETY AND HEALTH ADMINISTRATION

SUBJECT:

Report on Investigation of Coal Mine Outburst, Beatrice Mine, Beatrice Pocahontas Company, Keen Mountain, Buchanan County, Virginia, February 8,

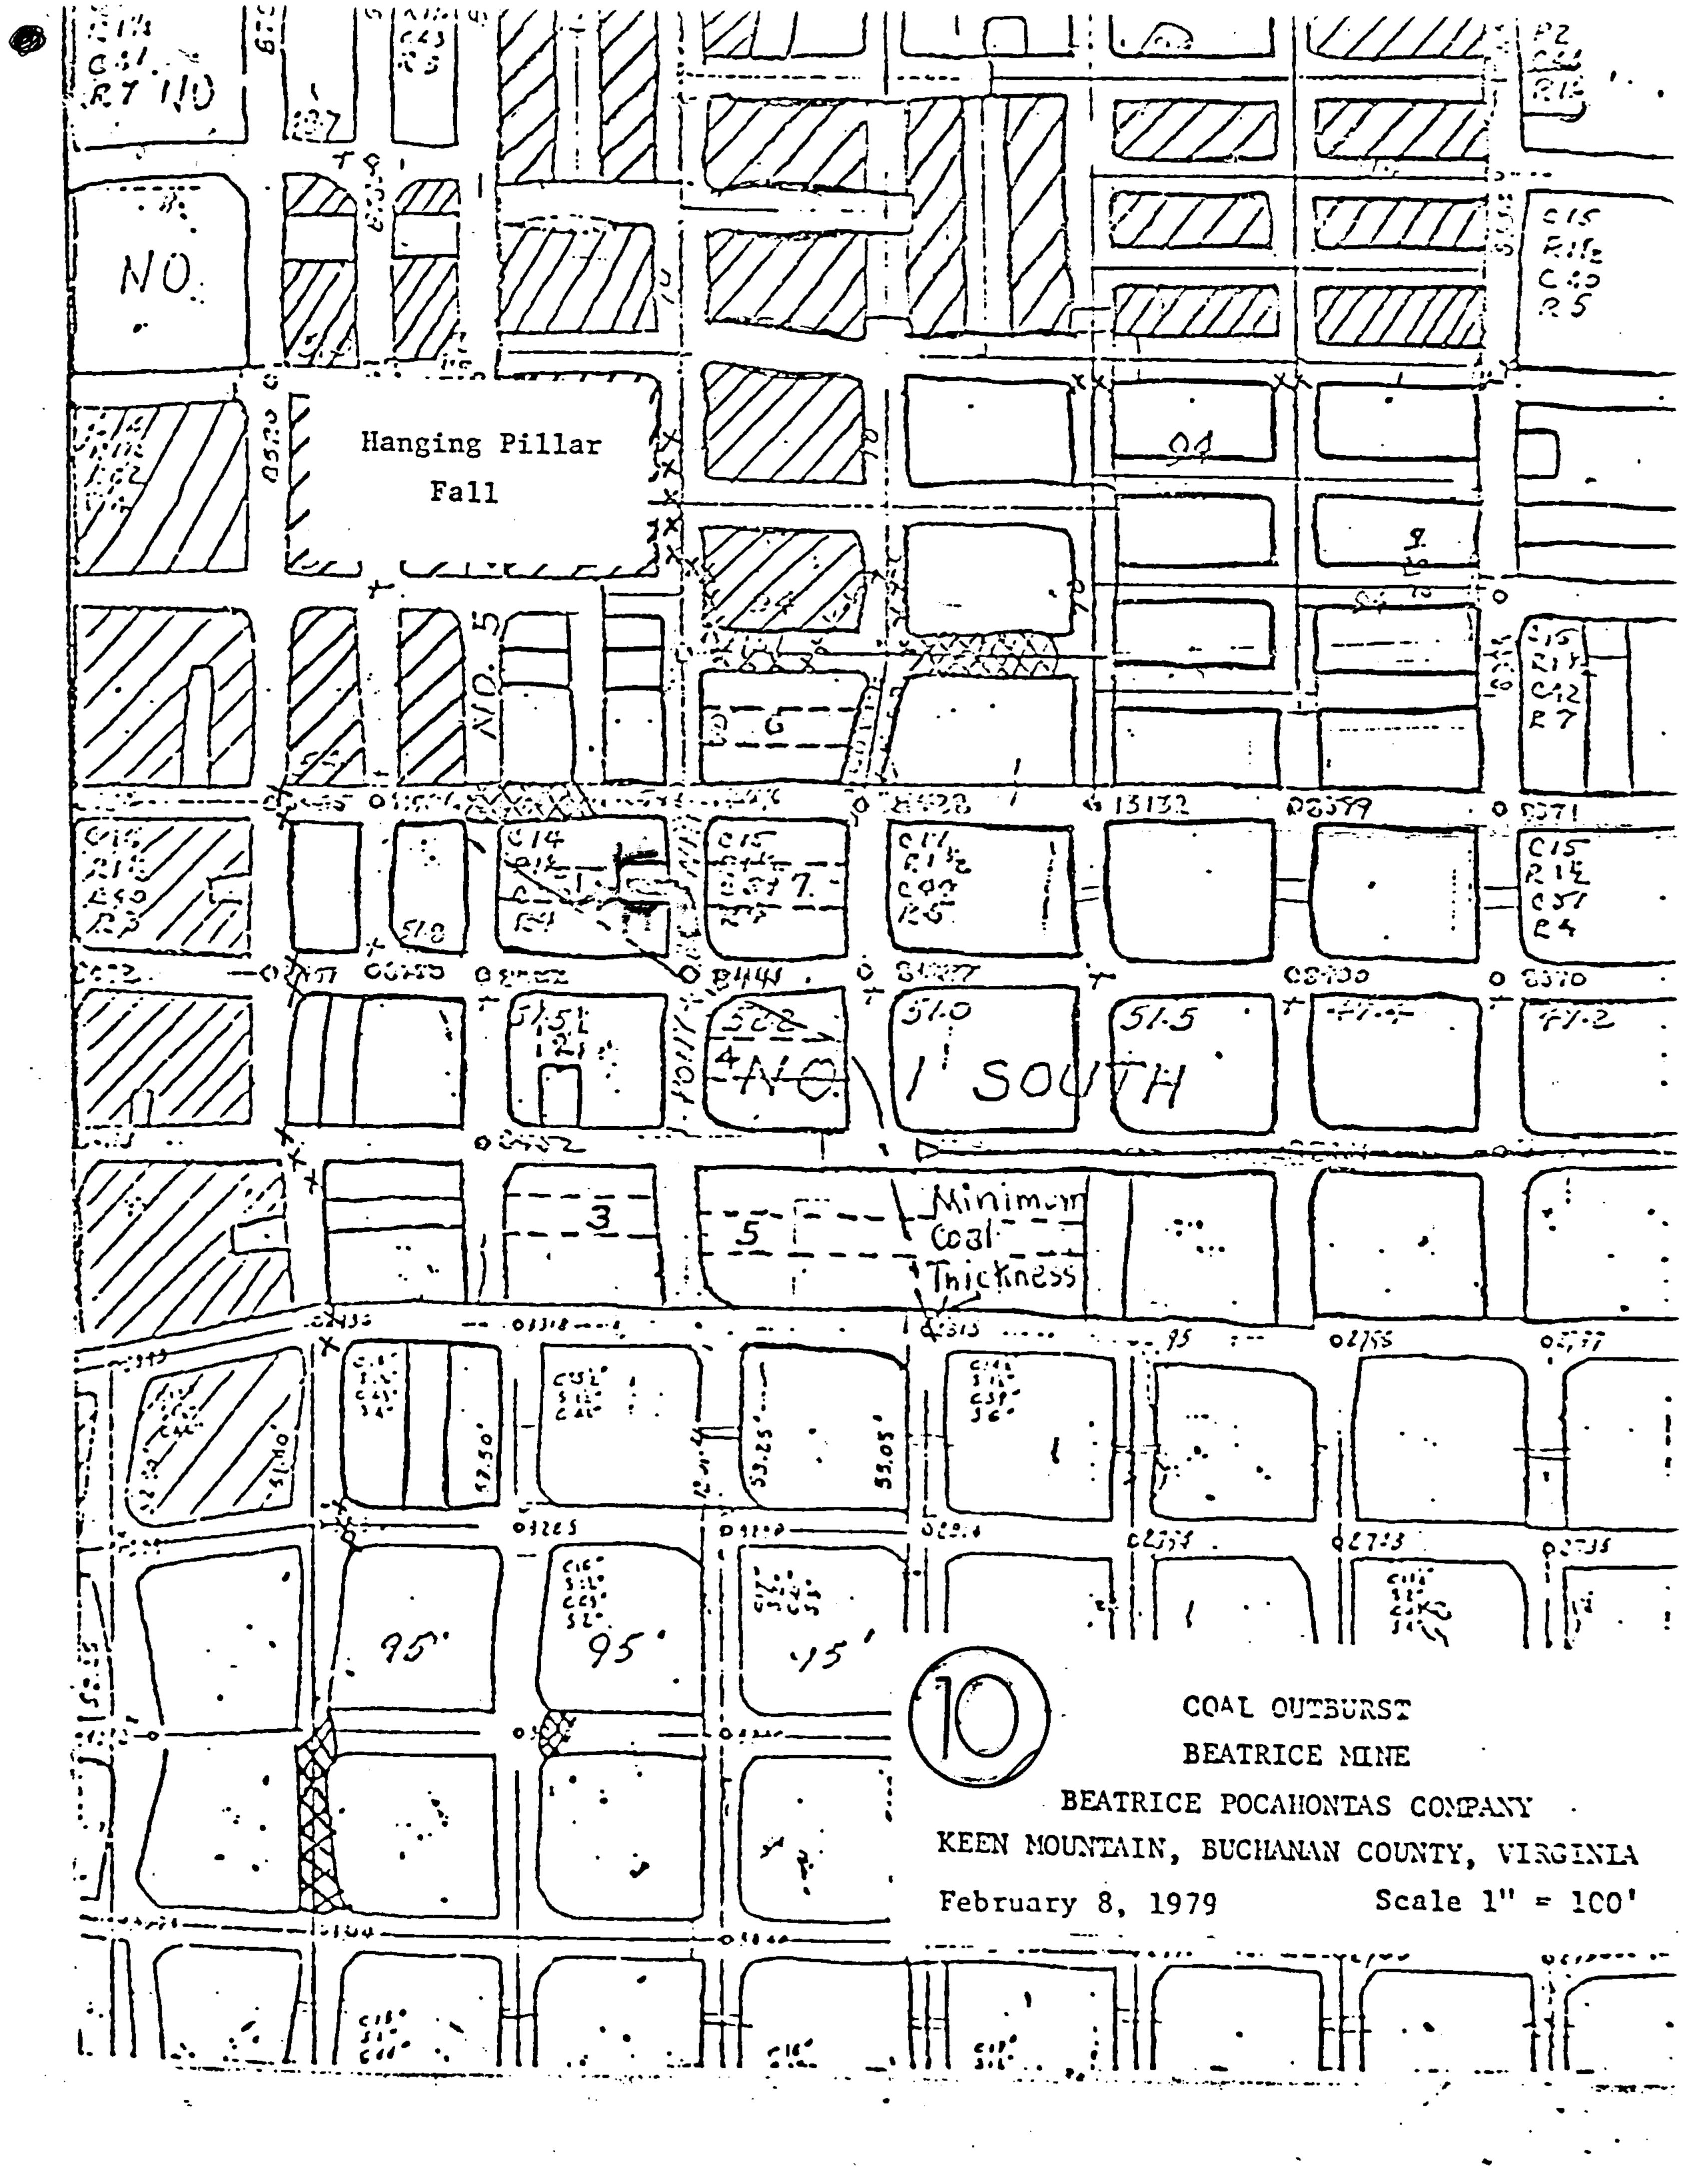
The investigation revealed that a considerable area of roof in the gob had not fallen and the coal thickness decreased 10 inches from the opening of the split to the face. These factors and the hard floor in this area led to the stress build-up that culminated in the outburst. Relatively little coal was ejected from the face; however, a void near the roof along the left side of the face was easily discernible.

This general area has been characterized by a strong floor which led to a plan to maintain small pillars along the pillar line. In view of the hanging pillar fall (see sketch) and strong floor revealed during development of the barrier pillar, it was planned to split the second row of large chain pillars outby the pillar line preparatory to resuming recovery of pillars. The outburst occurred during this phase of mining. In light of the marked undulation of the coalbed and the occurrence of the outburst, it was then planned to split the large pillars in the third row of pillars outby the pillar line with priority being given to the pillars containing the low coal (shown in sketch). Mining will be monitored closely to ascertain the effectiveness of this plan.
